Chevrolet New Onix Hatchback + 6 Airbags

CAR DETAILS

ADULT OCCUPANT PROTECTION

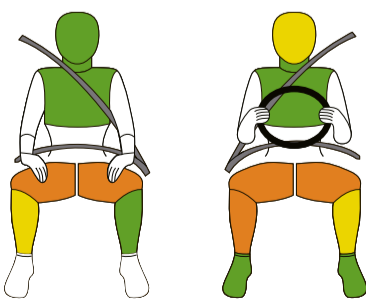
ODB FRONTAL

FRONT PASSENGER

DRIVER

PROTECTION ■ GOOD ■ ADEQUATE ■ MARGINAL ■ WEAK ■ POOR

Adult occupant: Frontal impact: The protection offered to the driver's head was adequate while passenger's head received good protection. Driver and passenger neck protection was good. Driver and passenger chest received good protection from the restraint systems. Driver and passenger knees showed marginal protection as they can impact dangerous areas behind the fascia. Driver tibias showed marginal and adequate protection, and Passenger's tibias showed adequate and good protection. Foot well area was rated as stable and showed insignificant deformation. Feet protection is good. The body shell was rated as stable. **Side impact:** The car offered good protection to head, abdomen and pelvis and adequate protection for the thorax. **Side Pole Impact:** Head, abdomen and Pelvis showed good protection while chest showed weak protection. **ESC:** The ESC was tested and its performance met the regulatory requirements of Latin NCAP. The car offers 2 frontal SBR as well as SBR for the 3 rear seating positions. All of the above explain the 5 stars for adult occupant protection.
